Manhole Inspection Summary

Manhole # S150__051MH

Insp Date: **4/4/08 1:17 PM**

Location Address: **445 brunswick st**

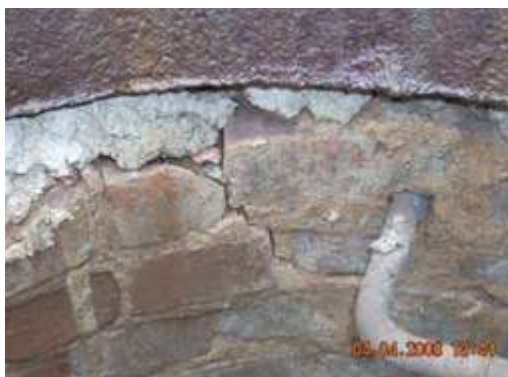
Defect 4

Condition: ☐ Sound ☒ **Cracked** ☐ Root Intrusion ☐ Loose Brick ☐ Deteriorated

cracked corbel bricks

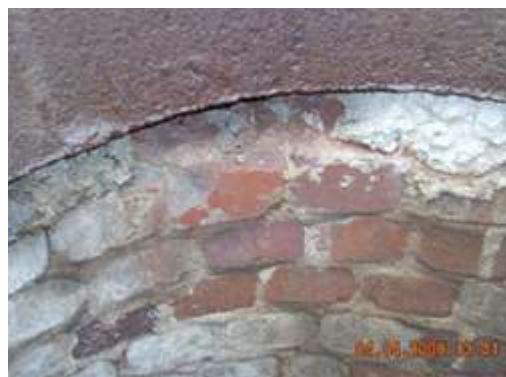
Defect 3

Condition: ☐ Sound ☐ Cracked ☐ Root Intrusion ☐ Loose Brick ☒ **Deteriorated**

deteriorated chimney

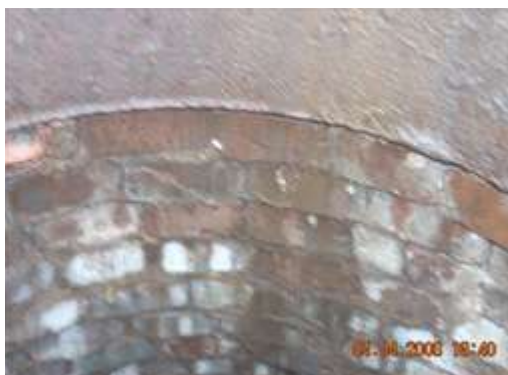
Defect 2

Infiltration: ☐ None ☒ **Joint** ☐ Cracks ☐ Mortar ☐ Roots ☐ Wall

infiltration @ chimney joint

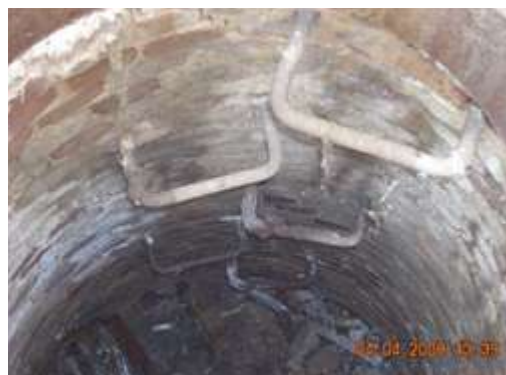
Defect 1

Count: **5** Missing: **0** ☒ **Corroded**

corroded steps

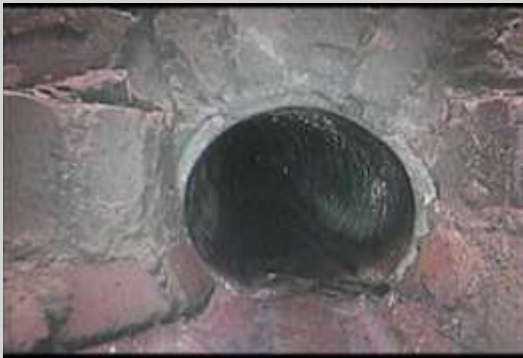
12 O'Clock Outflow

Pipe Height: **7.2** (in.) Rod and Bar (Angled)
Pipe Material: **Clay** ☐ Pipe Lined
Invert Depth: **9.08** (ft.) Flow Characteristics: **Slow**
Deposits: ☒ None ☐ Mud ☐ Sludge ☐ Debris ☐ Grease
Silt Depth: **0** (in.) Deposits Extent:
Infiltration: **Evidence** Pipe Seal Cond: **Cracked**

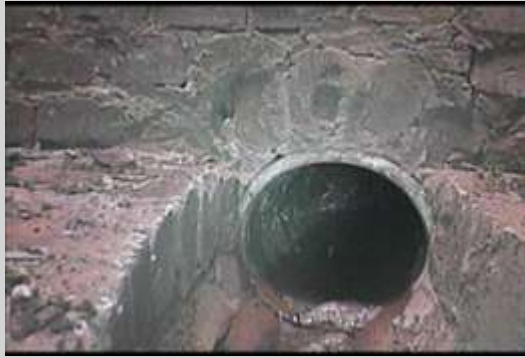
10 O'Clock Inflow

Infiltration: **Gusher** Pipe Seal Cond: **Sound**
